Your Inspection Report

524 & 526 Palmerston Blvd
Toronto, ON M6G 2P5

RE: Report No. 88222
524 & 526 Palmerston Blvd
Toronto, ON
M6G 2P5

Report No. 88222

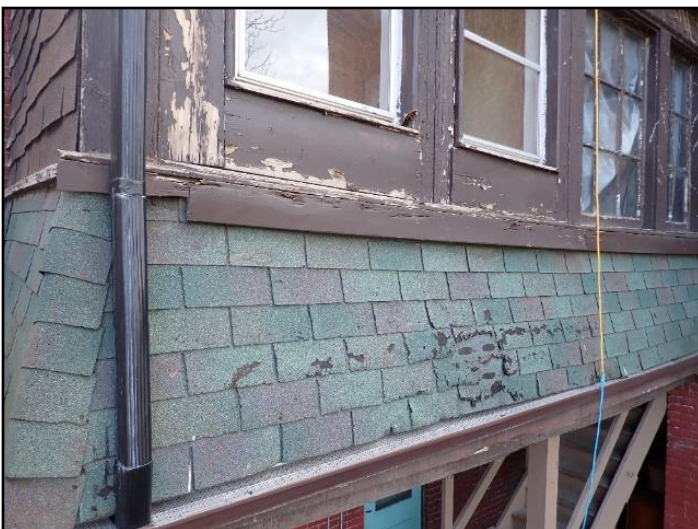
Worn shingle siding

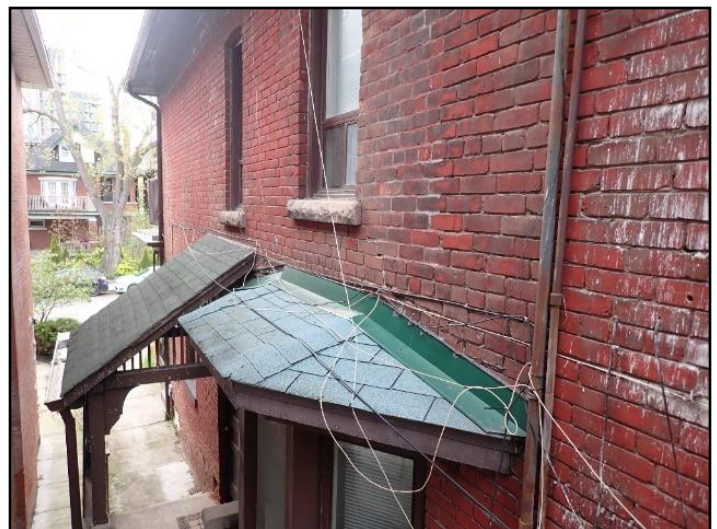
Mix of shingle colours

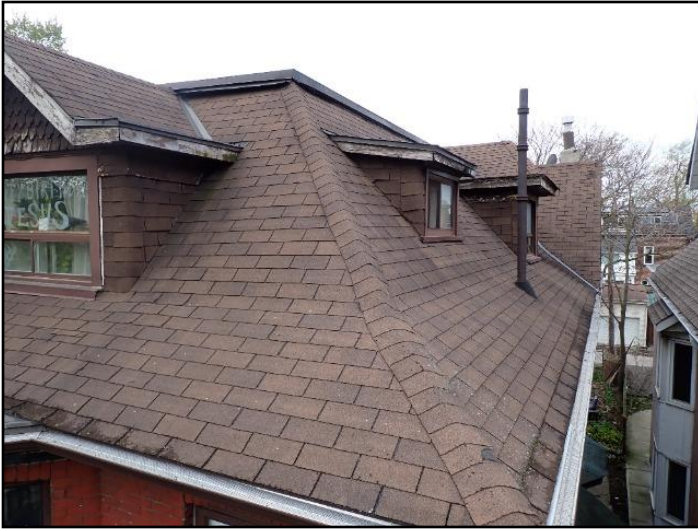
The shingles are worn, damaged in areas and replacement should be anticipated.

Shingles are in generally poor condition

Task: Repair / Replace

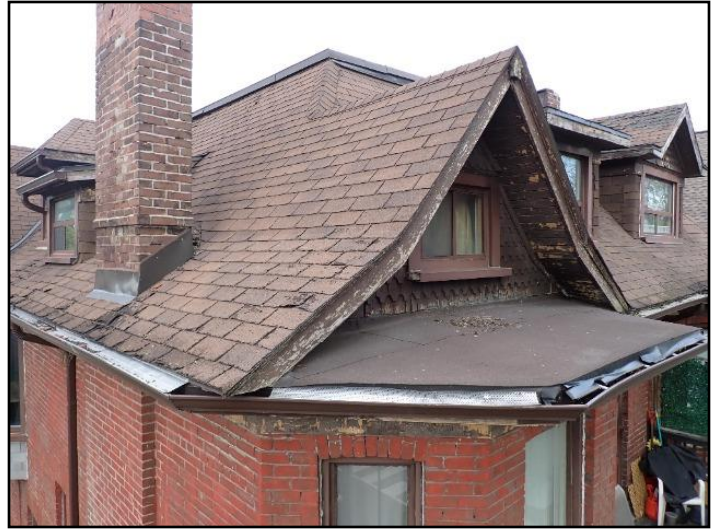
Shingles at or near end of life

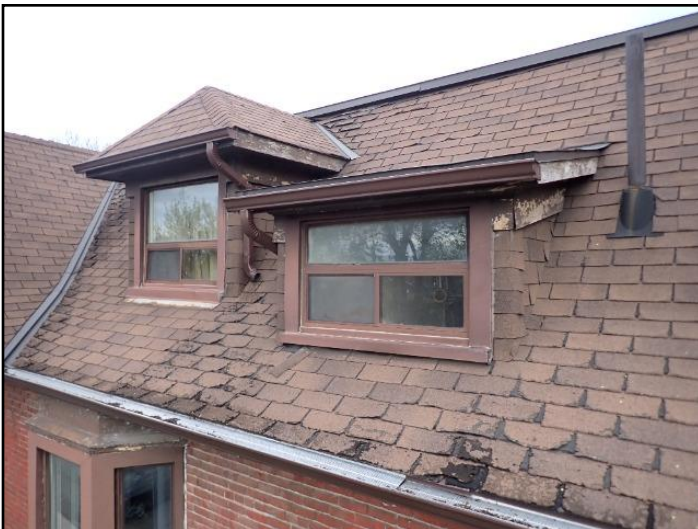
Shingles are in generally poor condition

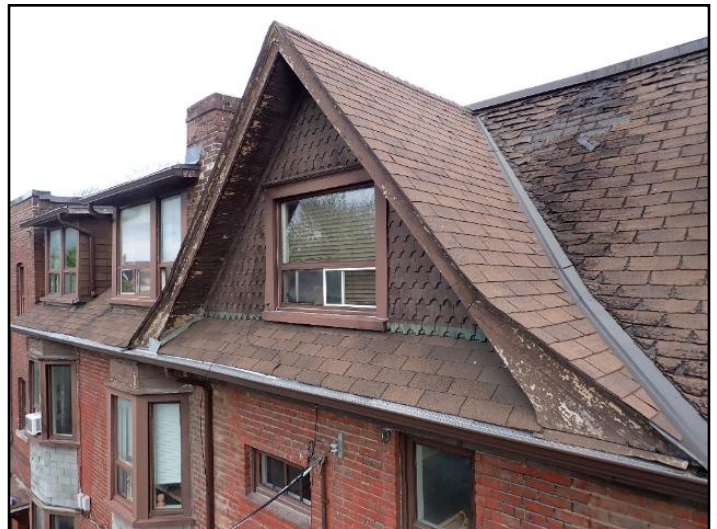
Shingles are in generally poor condition

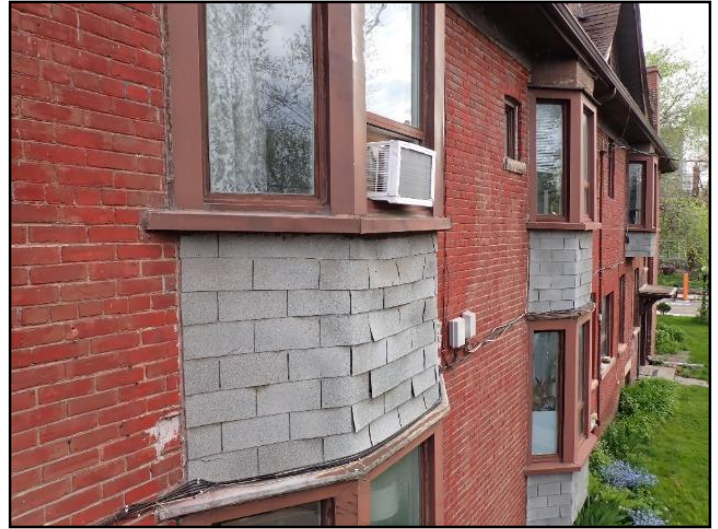
Loose, worn shingle siding

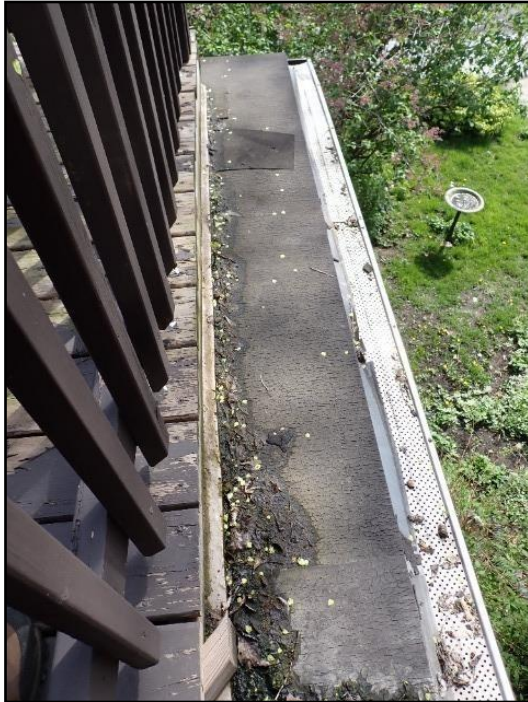
Cracked surface of flat roof under deck

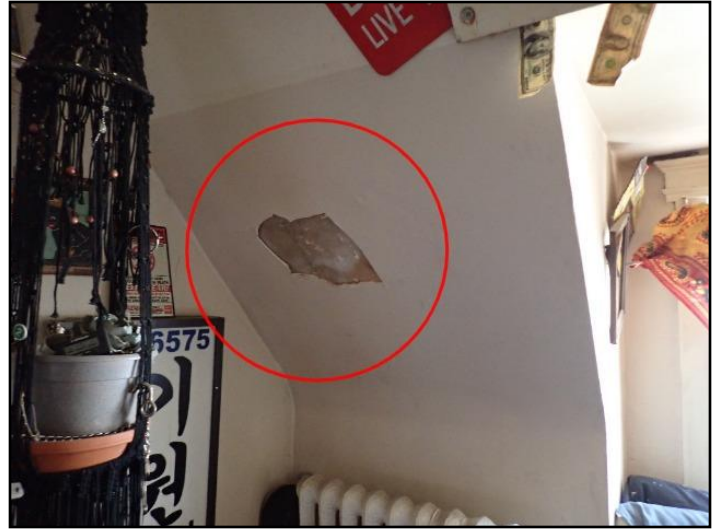
A couple of tenants reported leaking around the dormers and one also reported that the flat roof was leaking as well, especially around the skylight.

Tenant reported roof leak

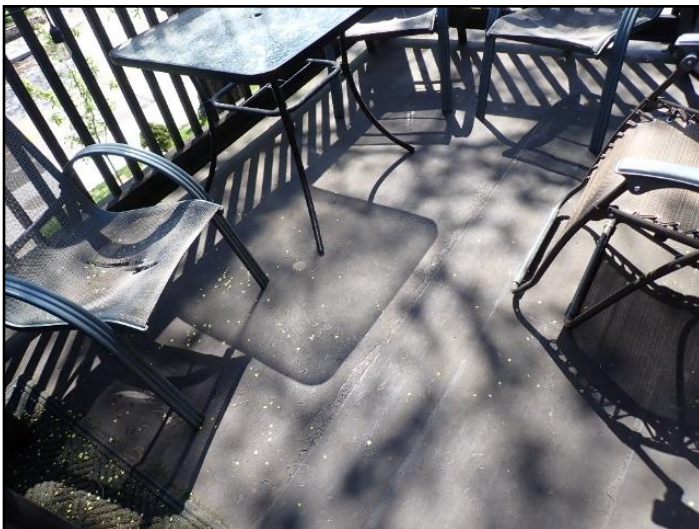
The condition of the balcony flat roofing looks old too.

Older balcony roofing

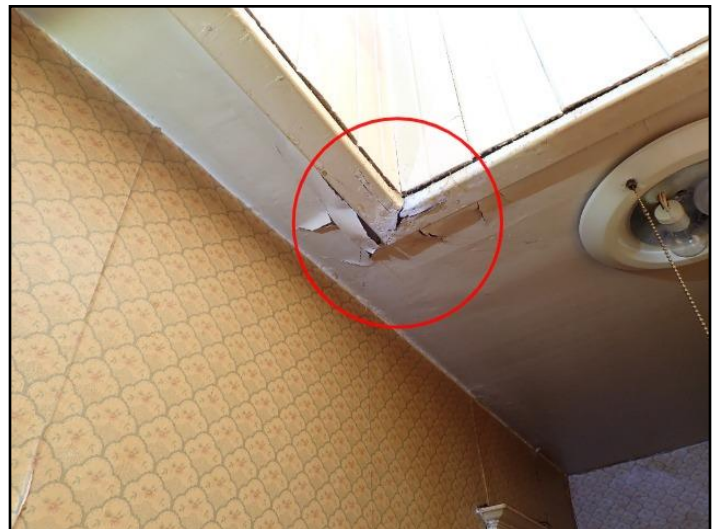
Tenant reported skylight leak

Extra cost would involve removal/replacement of any decking plus the cost of replacing the skylight.

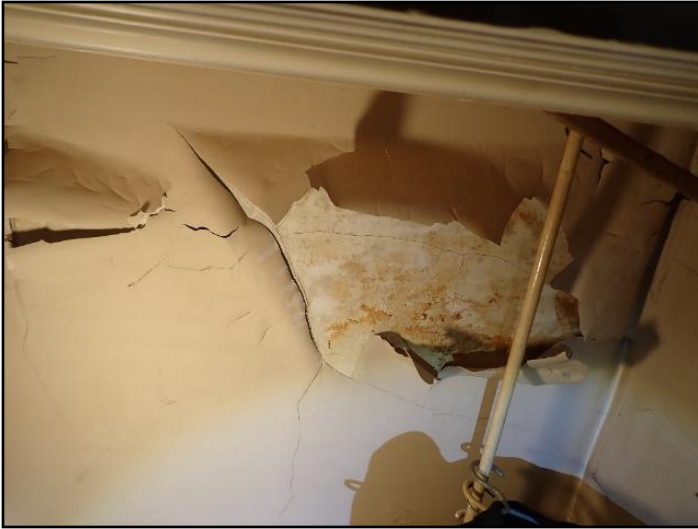
Tenant reported roof leak

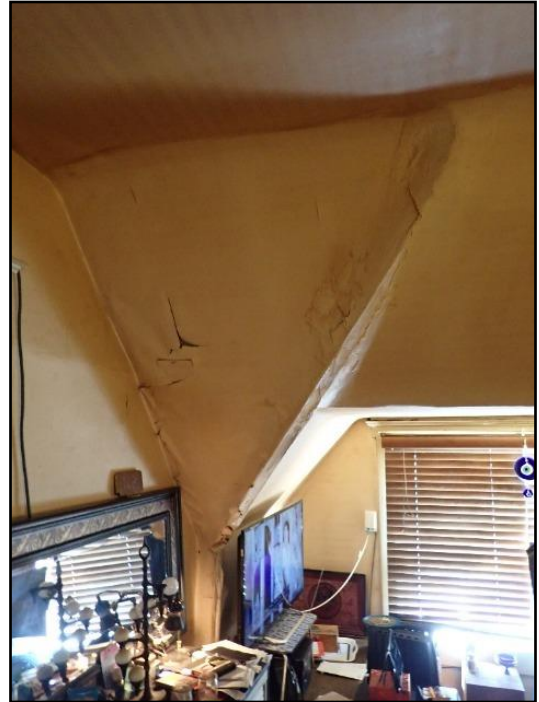
Tenant reported stains from roof leak

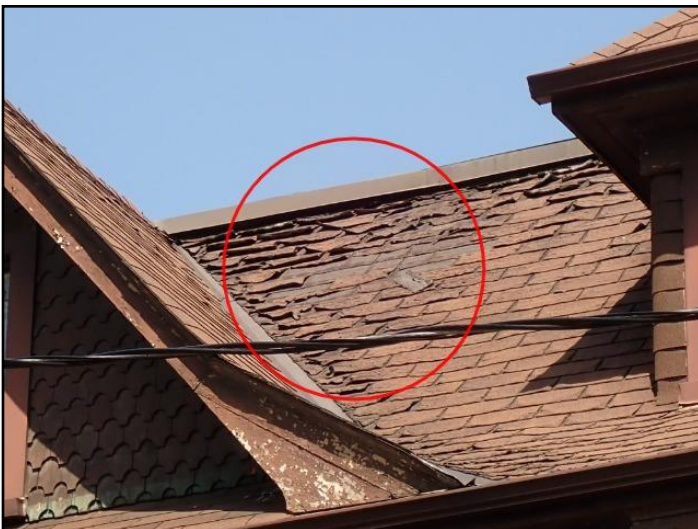
Damaged shingles

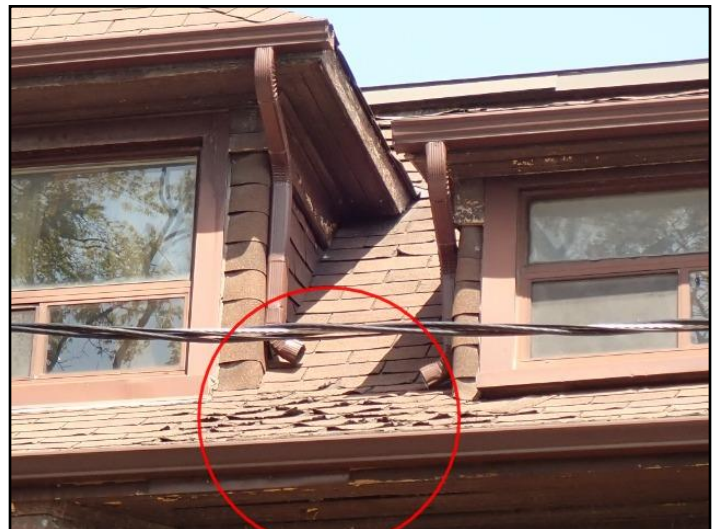
Damaged shingles

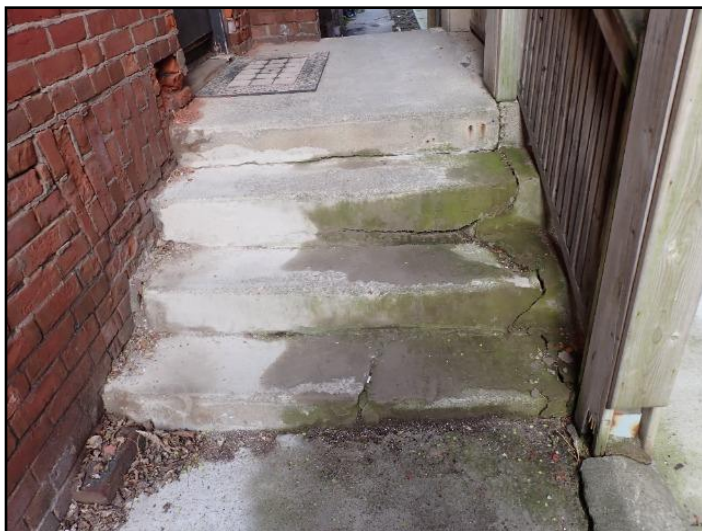
Steps are cracked/settled

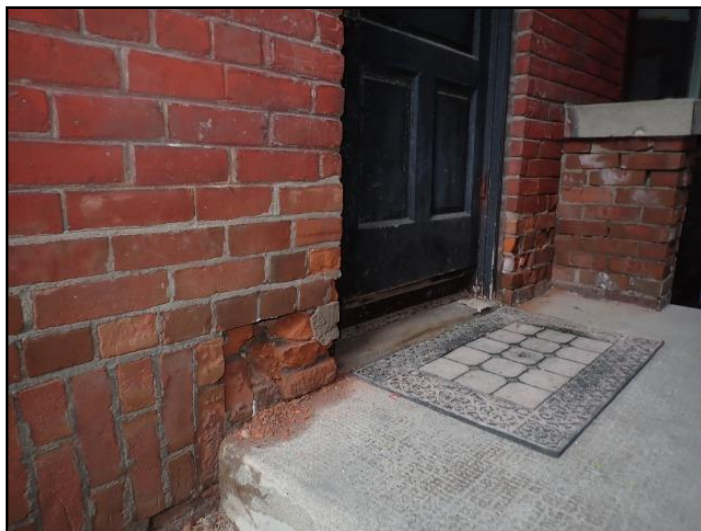
Some deteriorated brick noted

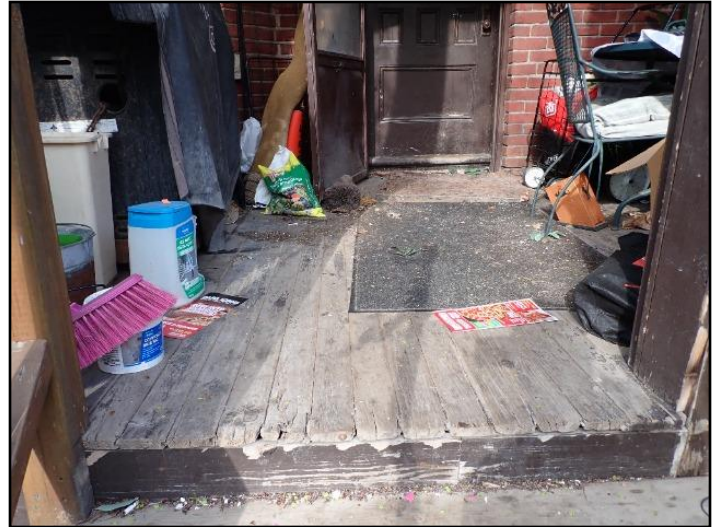
Porch flooring is weathered/worn

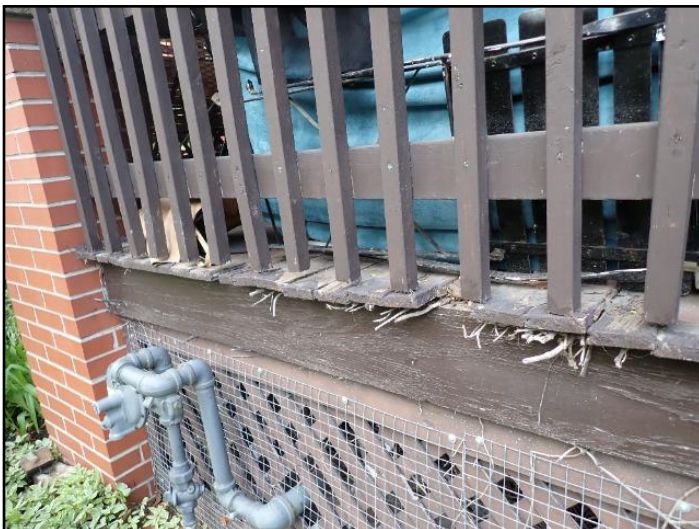
Porch flooring is weathered/worn

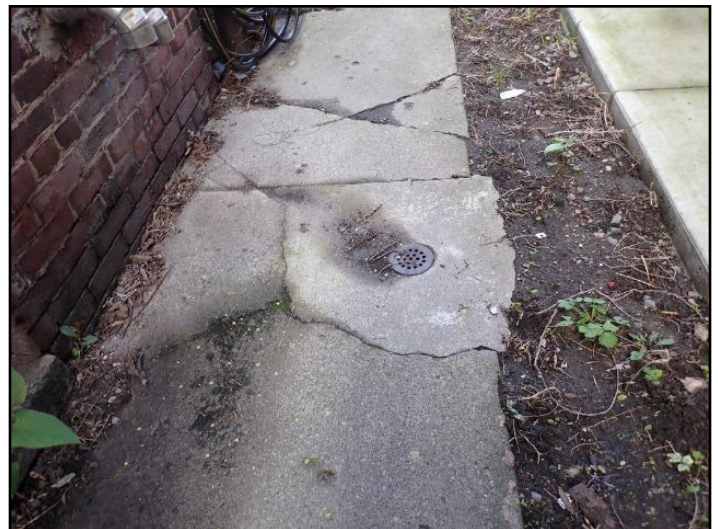
Sidewalk is cracked

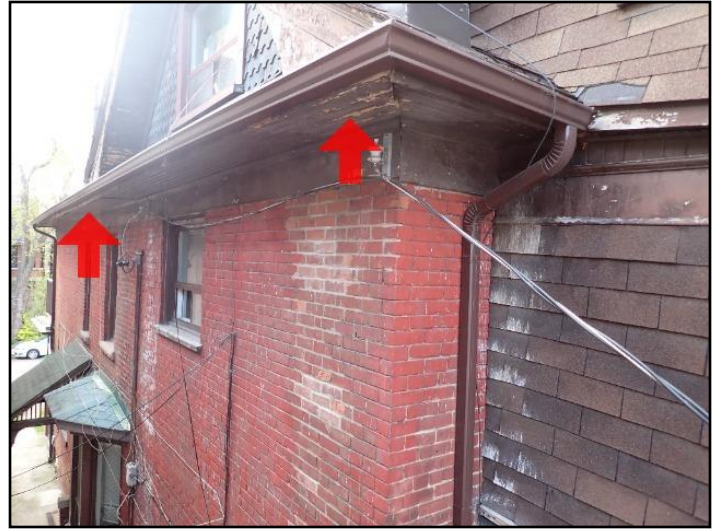
Soffit/fascia could be capped to lower maint.

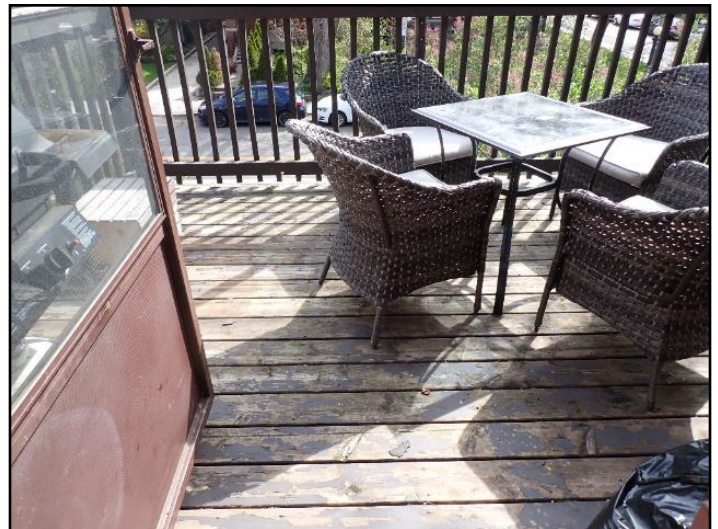
Weathered deck on balcony

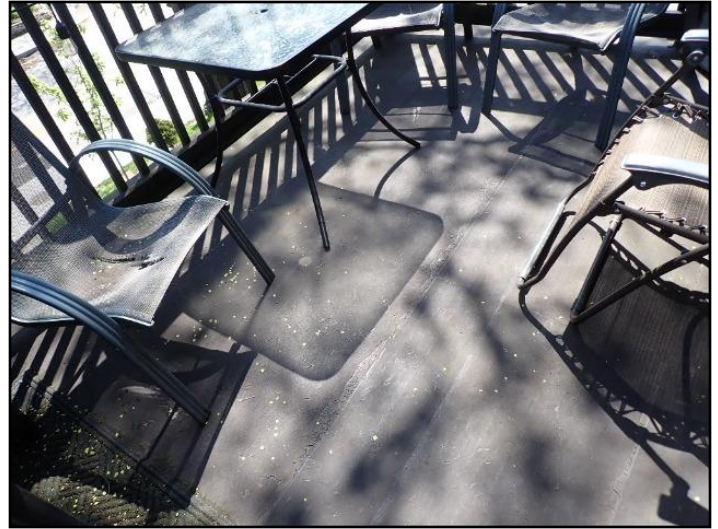
Deck missing to protect roof?

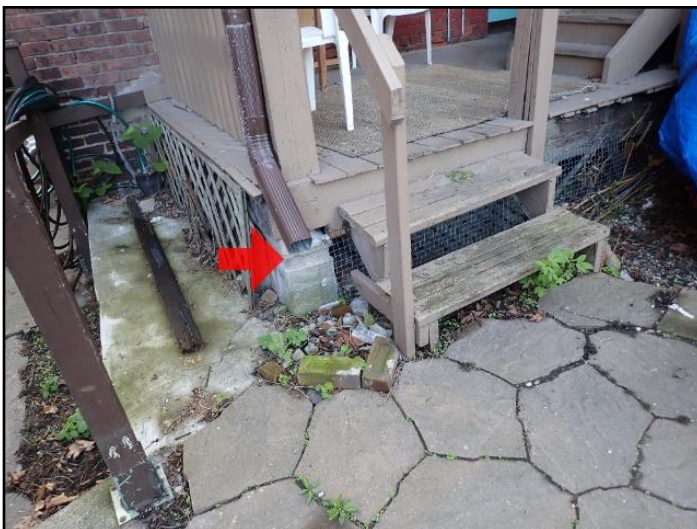
Maintain discharge well away from foundation

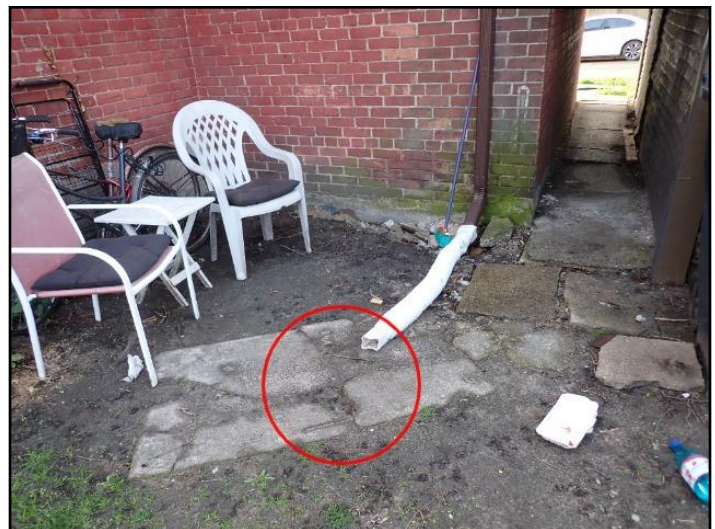
Maintain discharge well away from foundation

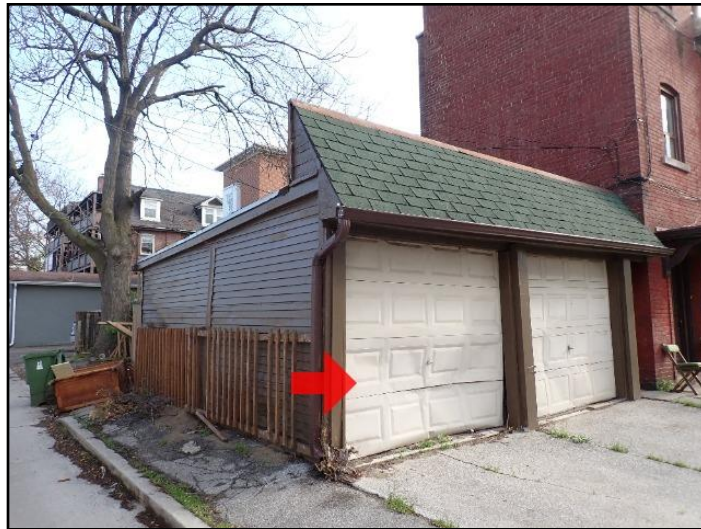
Condition: • Damage

Damaged garage door

Task: Replace

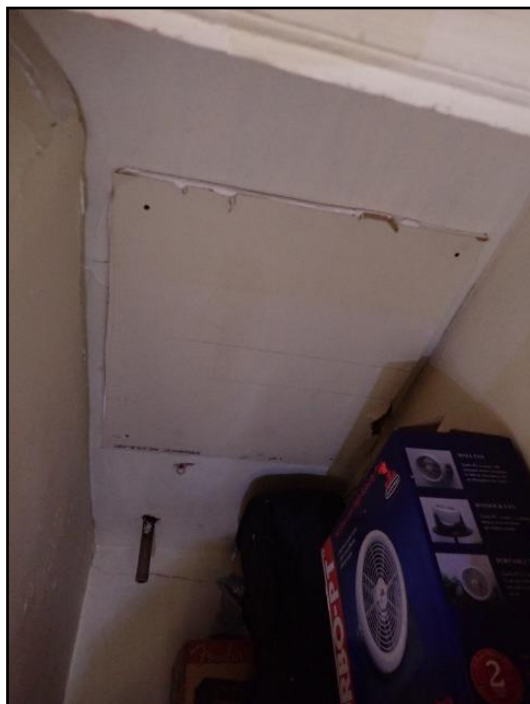
Attic access in Unit 4

With awkward/sealed access, we were unable to comment on the conditions in the Attic.

Task: Provide access and inspect to verify conditions

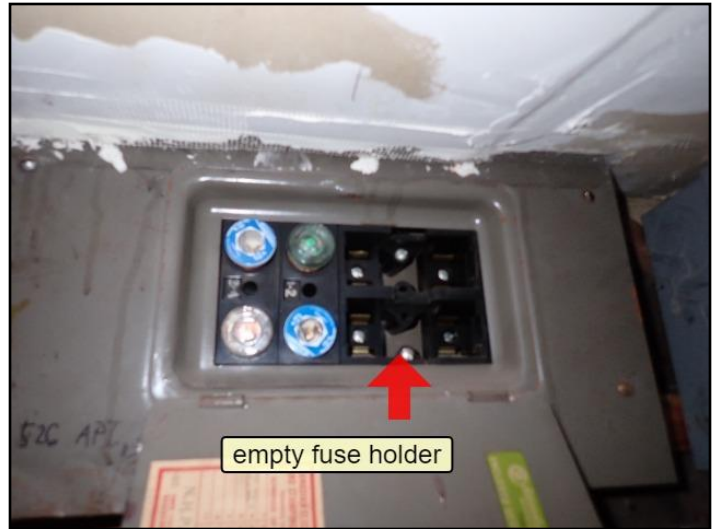
Openings in panel

Task: Improve

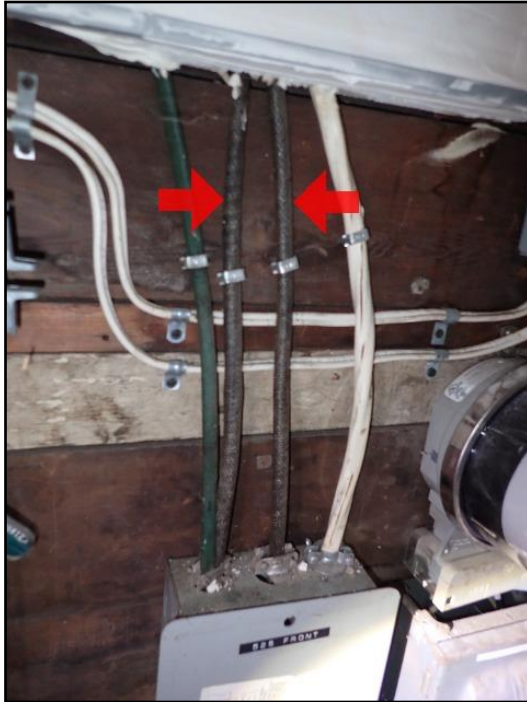
While some of the house has been rewired, live knob-and-tube wiring was noted and should be suspected where there are ungrounded outlets.

Knob-and-tube wiring

Task: Replace when remodeling

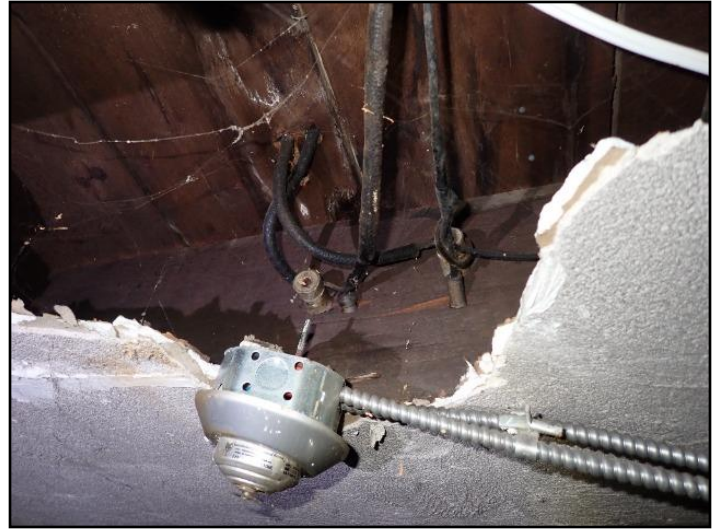
Knob-and-tube wiring

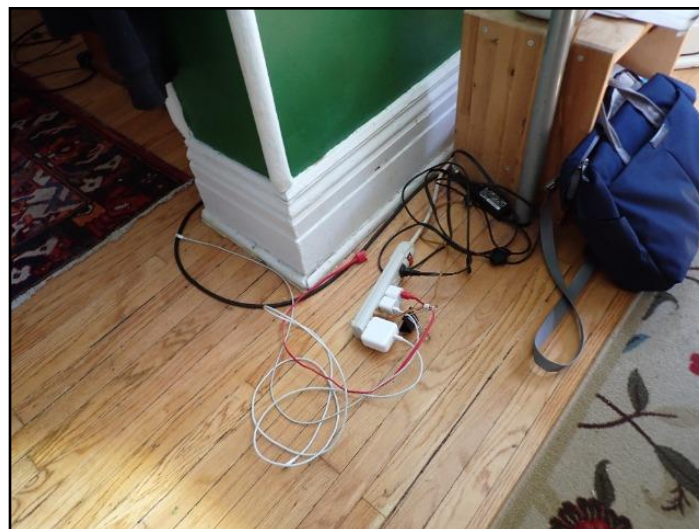
More outlets needed

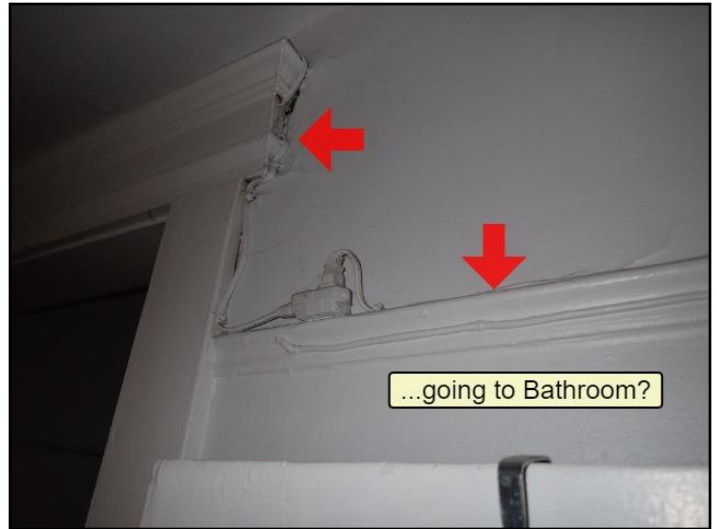
Low quality installation

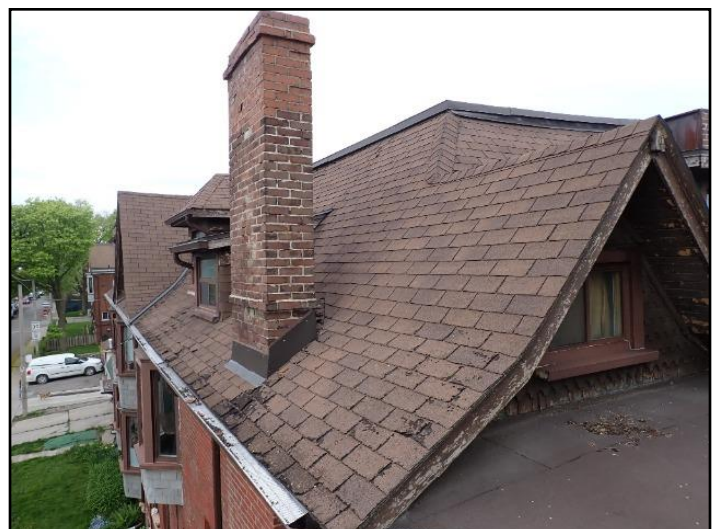
Abandoned chimney

Otherwise, if there are no plans to resurrect the fireplaces, the chimneys could be removed (at least down to the roof line) to lower the risk of a roof leak.

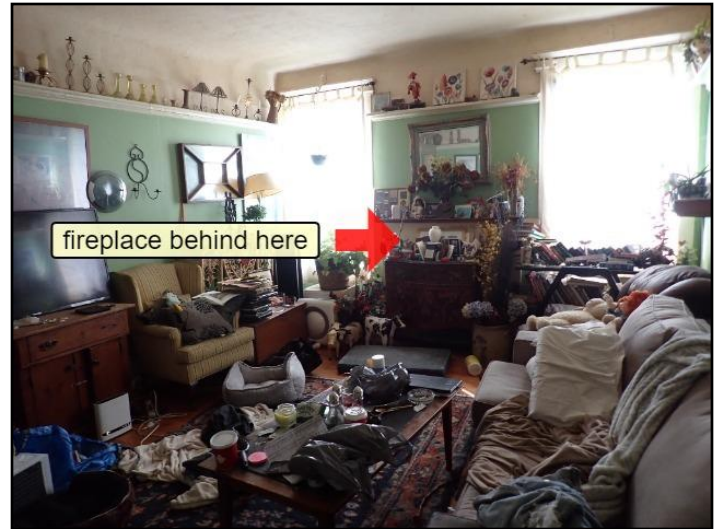
Not functional

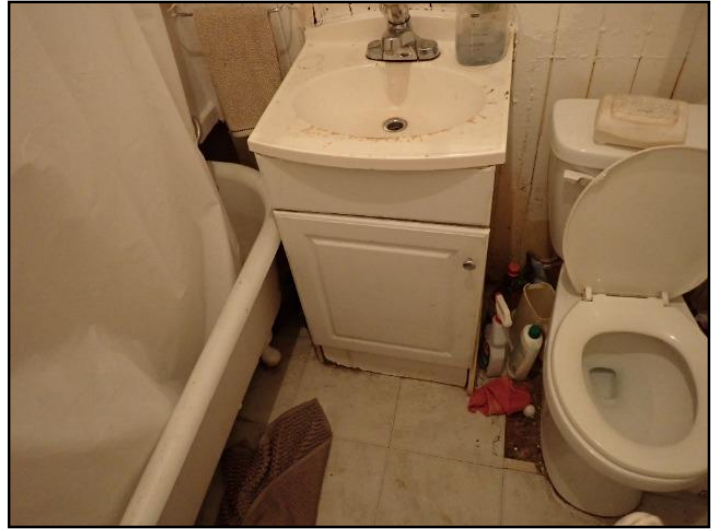
Older Bathroom fixtures/finishes

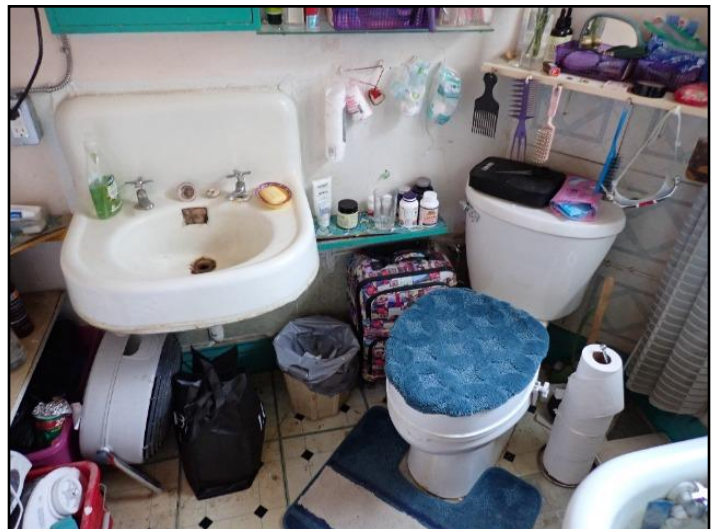
Older Bathroom fixtures/finishes

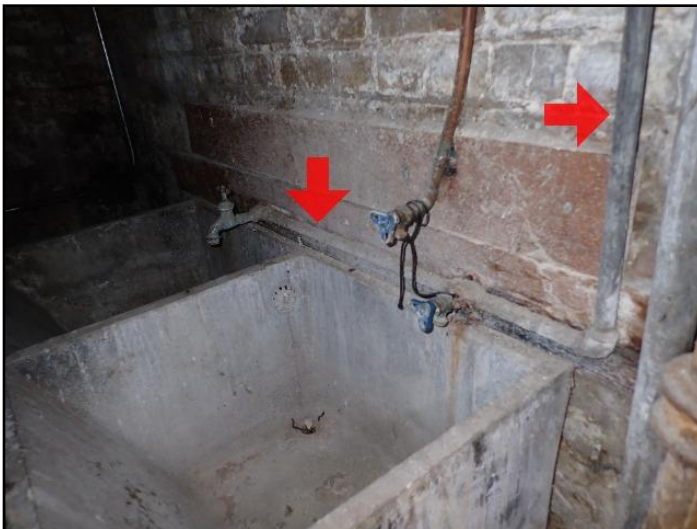
This piping is beyond its normal service life. The interior is typically corroded reducing water pressure and volume. Eventually the pipe walls fail and leaking will occur.

Galvanized steel piping

Task: Replace

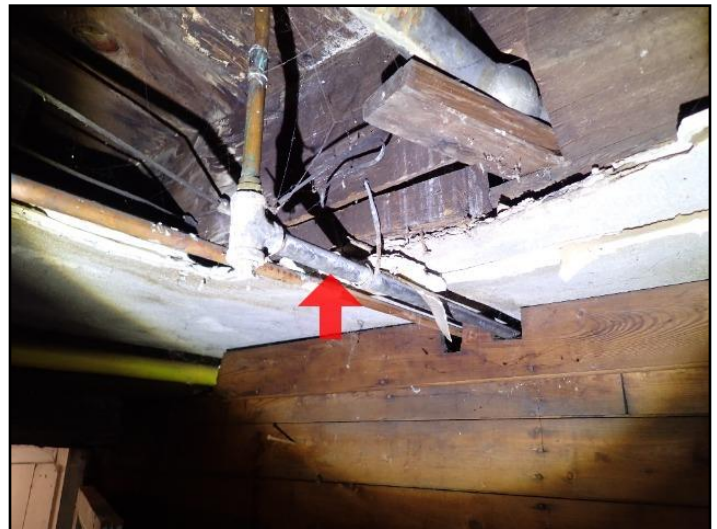
Galvanized steel piping

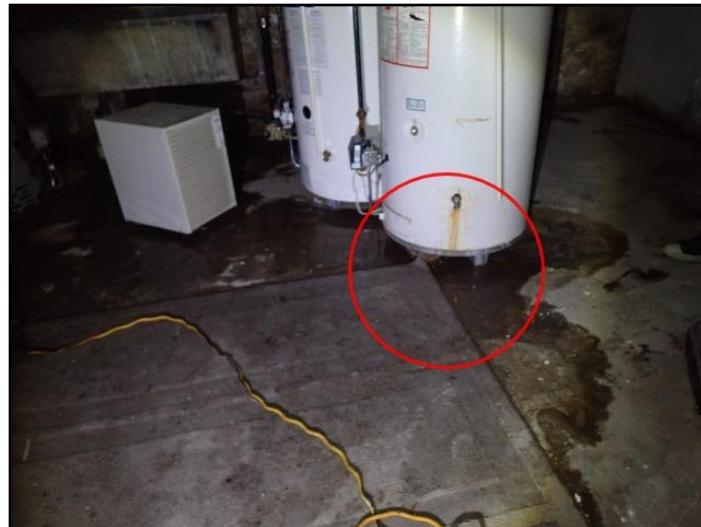
One water heater was leaking and scheduled to be replaced.

Leaking water heater

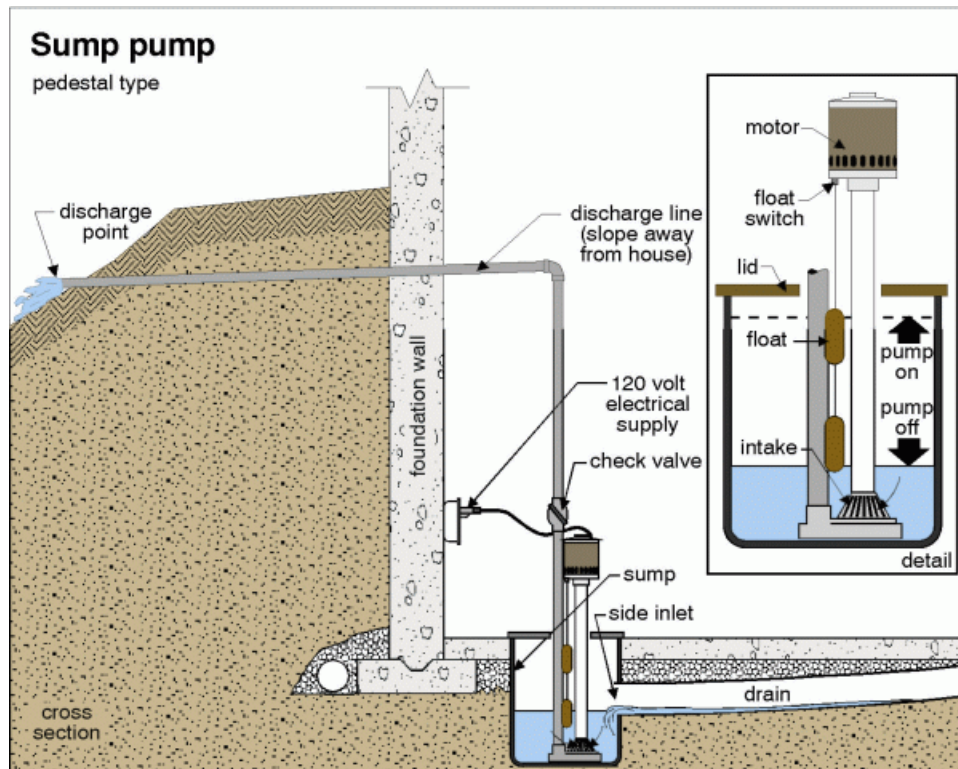
Condition: • There is a large cavity with water in it and an old rusted sump pump in the same vicinity.

Cavity on basement floor

Task: Further evaluation / Improve

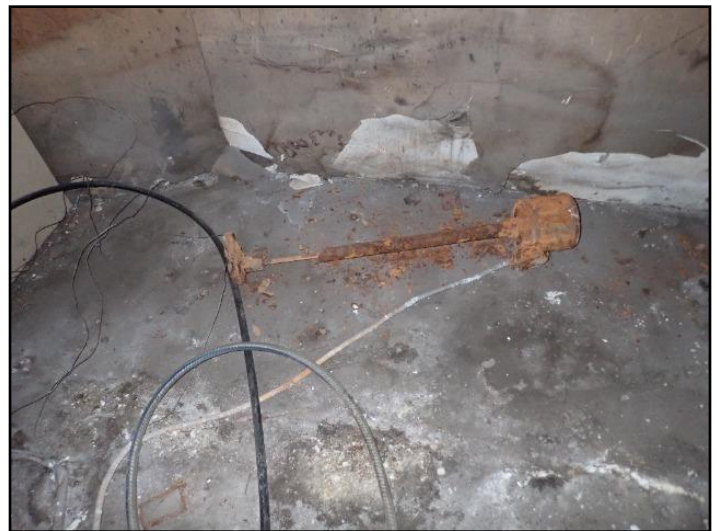
Old sump pump

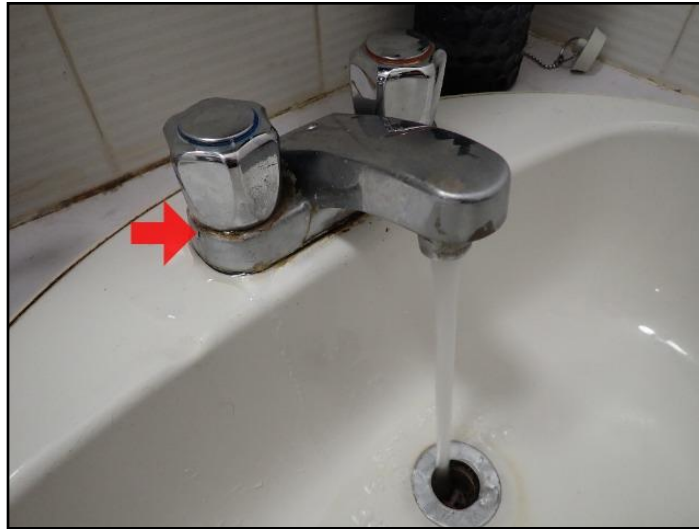
Drip, leak

Task: Repair / Replace

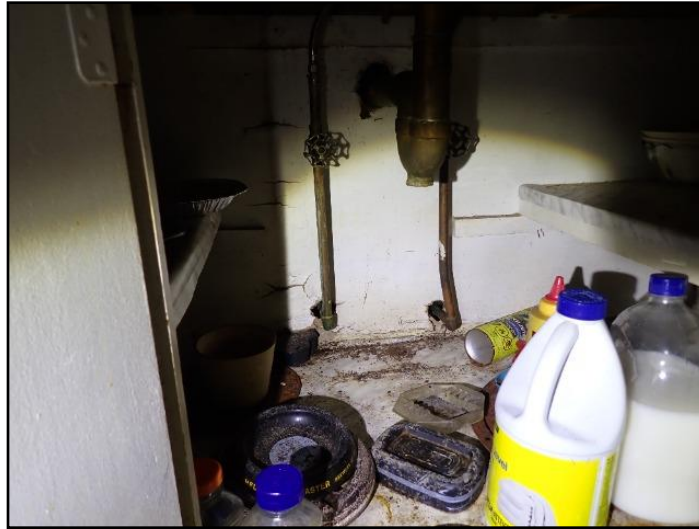
Leak

Task: Repair

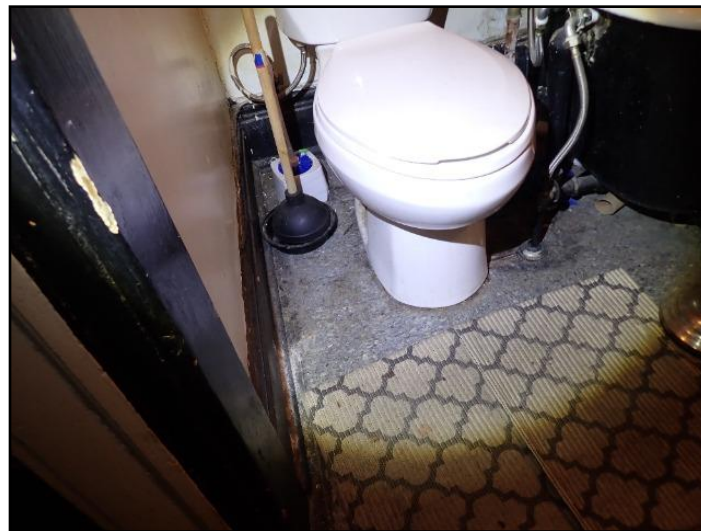
Loose toilets are more susceptible to losing the seal between the closet flange and the toilet and ultimately leaking.

Loose toilet

If the toilet bolts have been tightened and the toilet is still loose because the floor is uneven, plastic shims and/or caulking around the base can help.

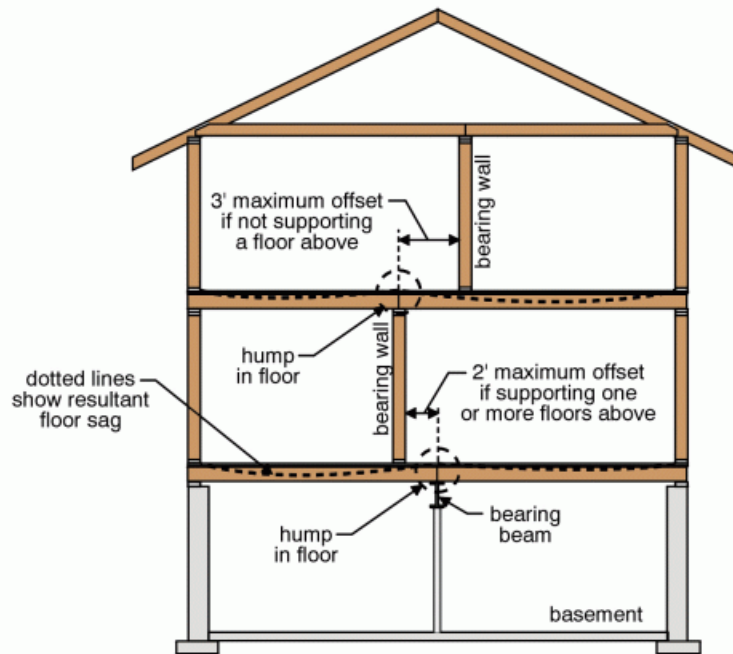
Often it can be attributed to age (gravity/sagging). Other times it can be structure that is offset, undersized or has been altered or damaged over the years (e.g. notched floor joists, excessive spans, rearranged/removed walls, insect damage, etc.). Sometimes poor workmanship can also be a contributor.

Sloped flooring

The most common time to address them is when renovating or replacing the flooring.

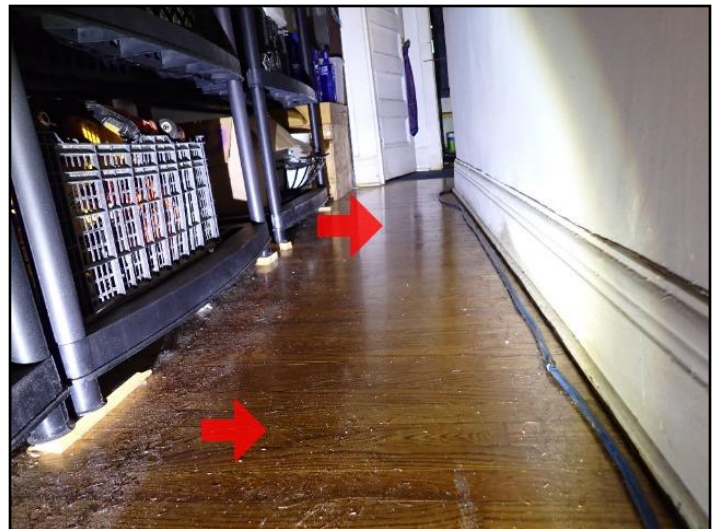
Sloped flooring

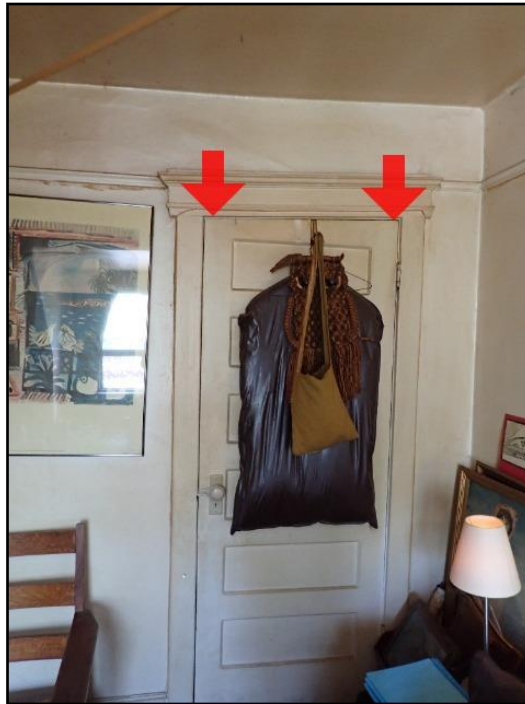
Out-of-square door opening(s)
