Your Inspection Report

524 & 526 Palmerston Blvd
Toronto, ON M6G 2P5

RE: Report No. 88222
524 & 526 Palmerston Blvd
Toronto, ON
M6G 2P5

Report No. 88222

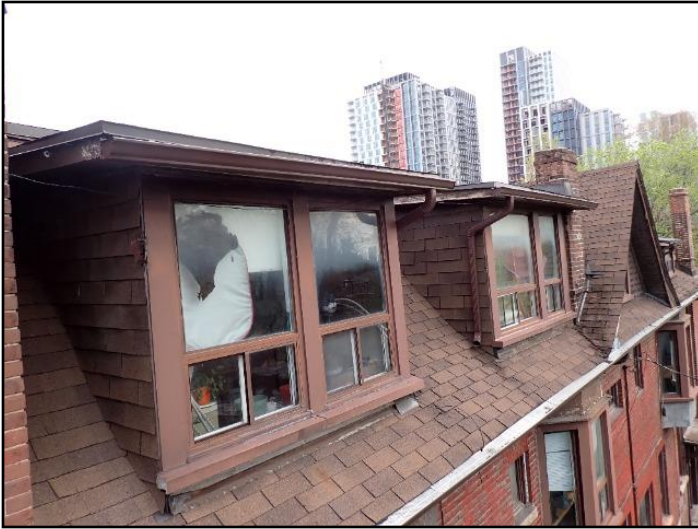
Condition: • At or near end of life

The shingles are worn, damaged in areas and replacement should be anticipated.

Shingles at or near end of life

Task: Repair / Replace

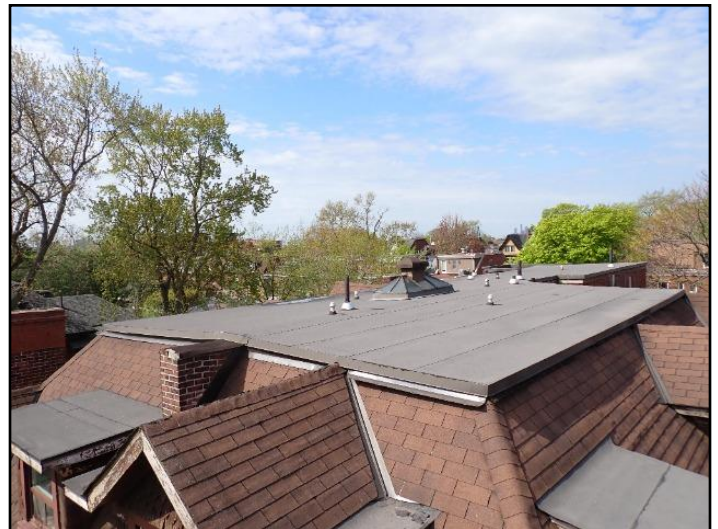
A couple of tenants reported leaking around the dormers and one also reported that the flat roof was leaking as well, especially around the skylight.

Upper flat and dormer roofs

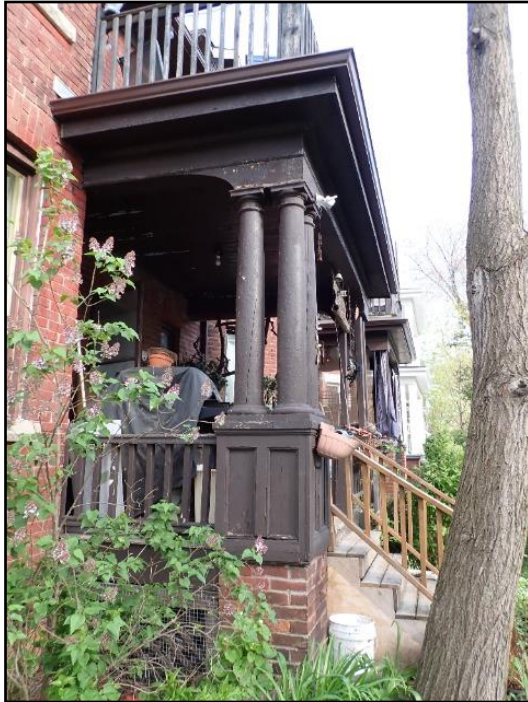
Wood trim needs attention

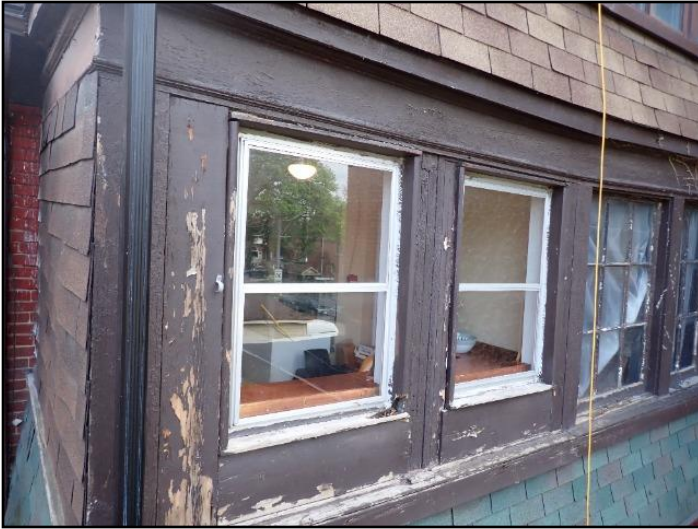
Wood trim needs work

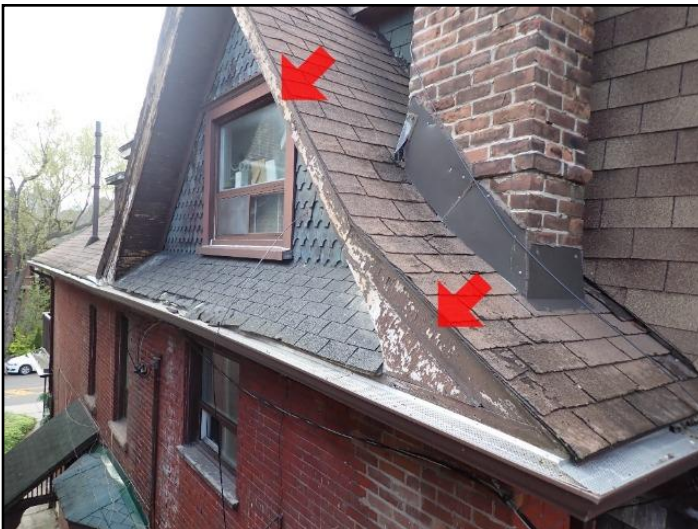
Wood trim needs work

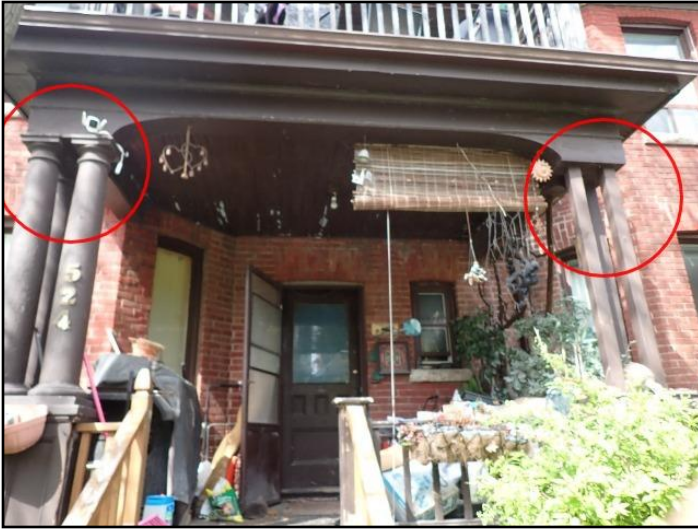
Mismatched columns

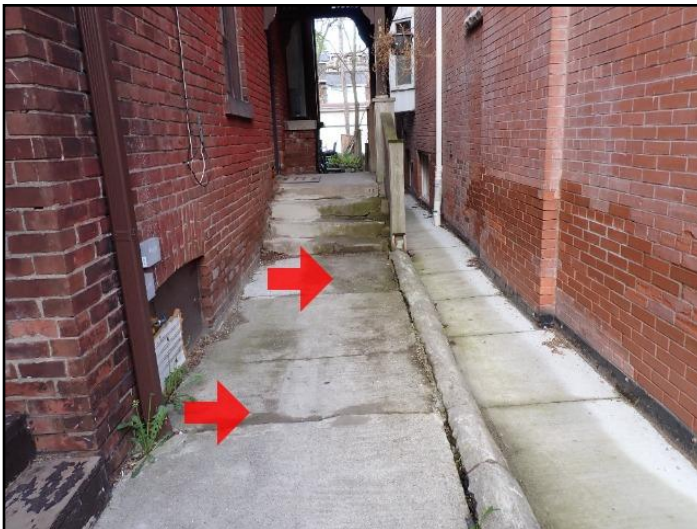
Maintain slope away from house

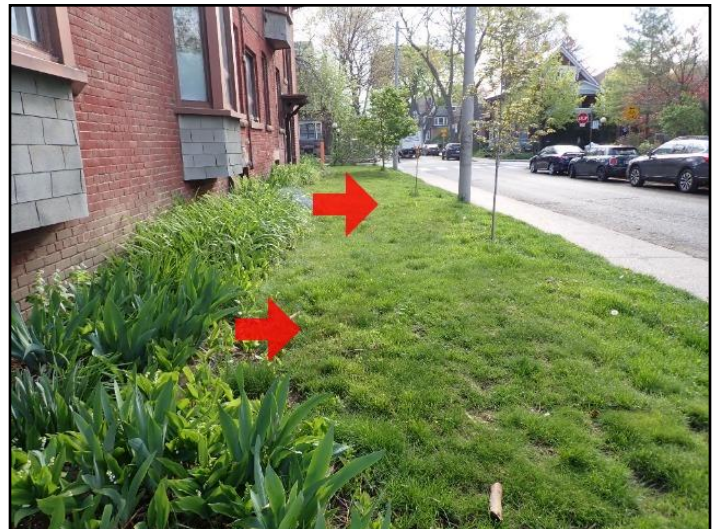
Maintain slope away from house

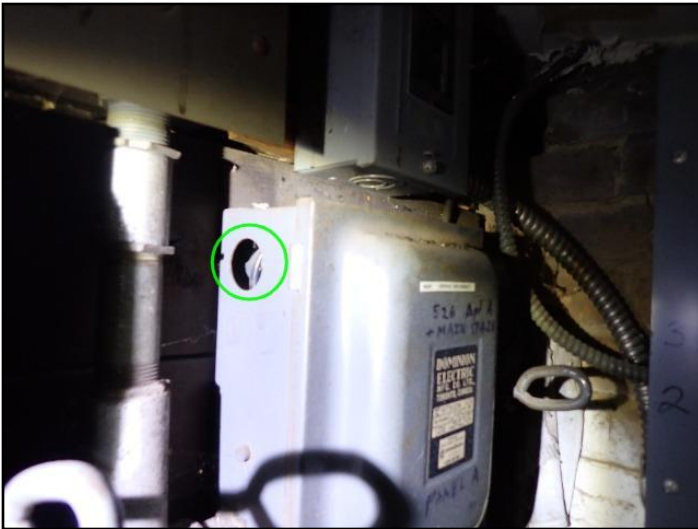
Openings in panel

Task: Improve

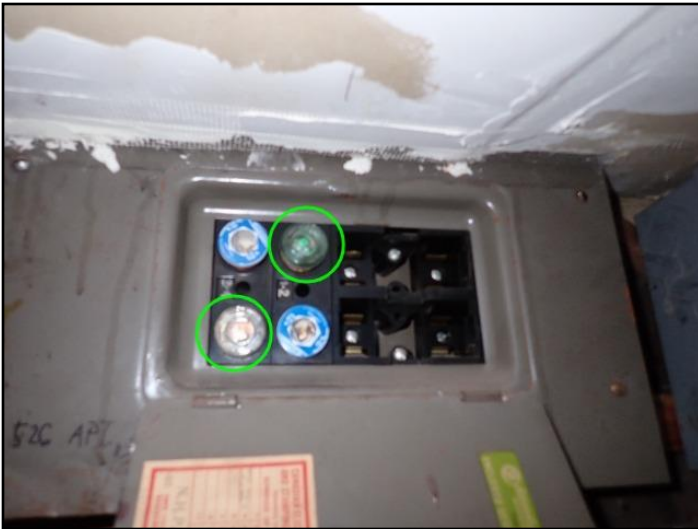
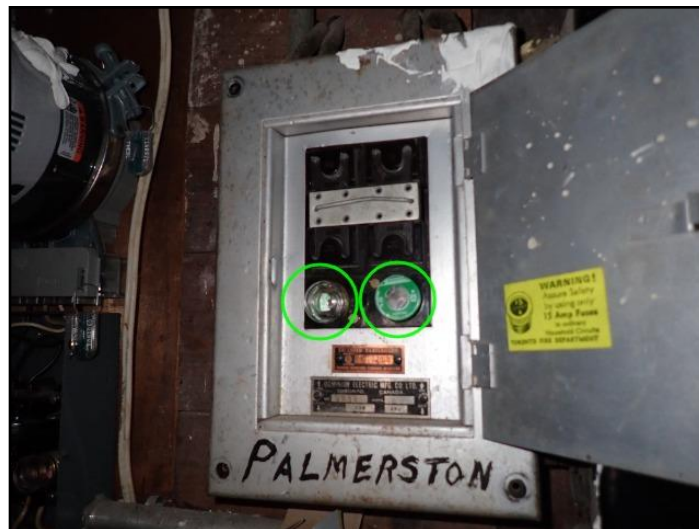
Fuses suspected to be too big

An electrician should check all wiring when fuses are replaced.

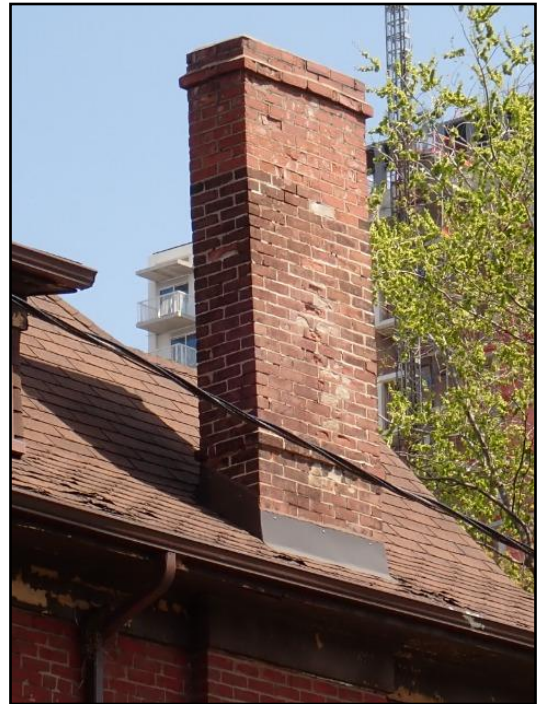
Abandoned chimney

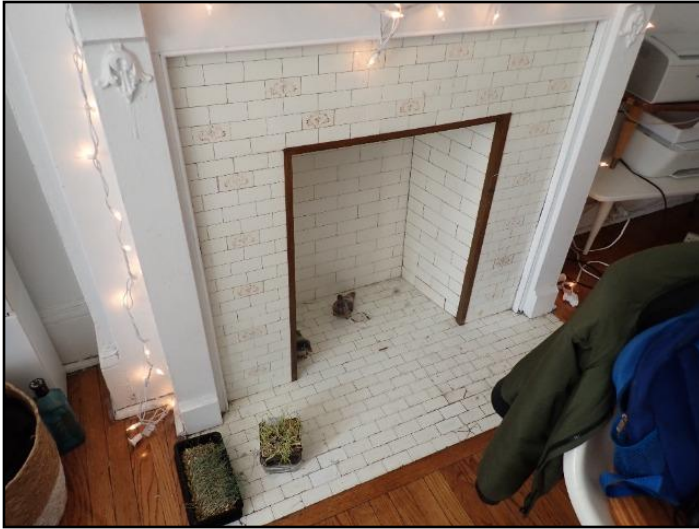
Non functional fireplace

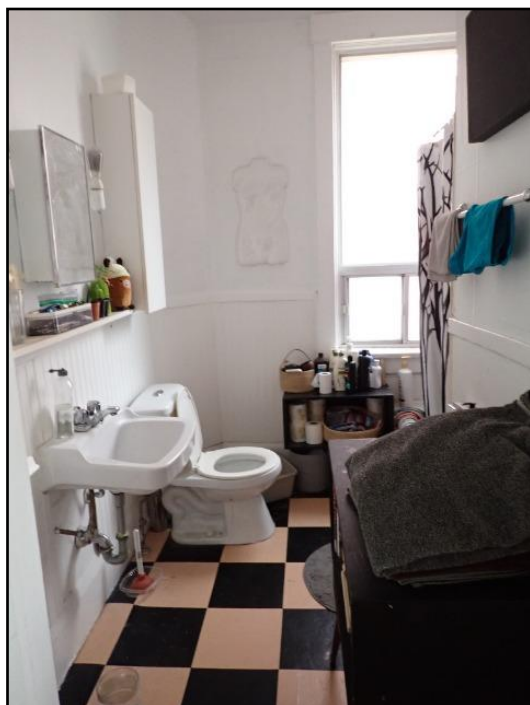
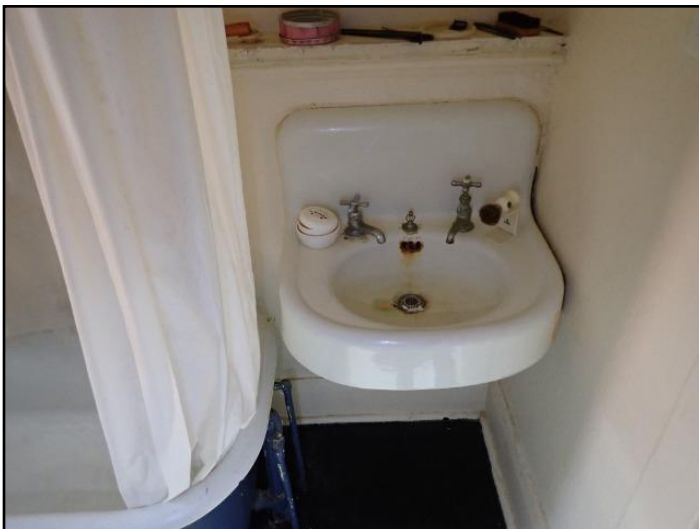
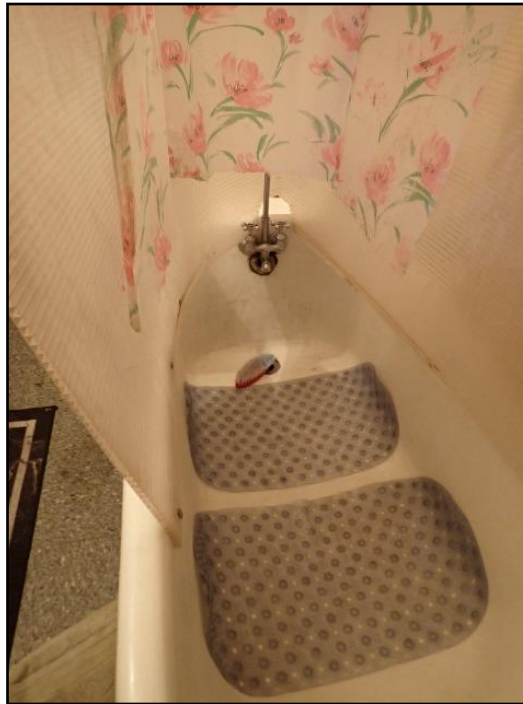
The plumbing fixtures and finishes, while functional, are arguably dated and in various states of repair.

Older Bathroom fixtures/finishes

Modest Bathroom renovations start at \$10,000 and can easily go higher.

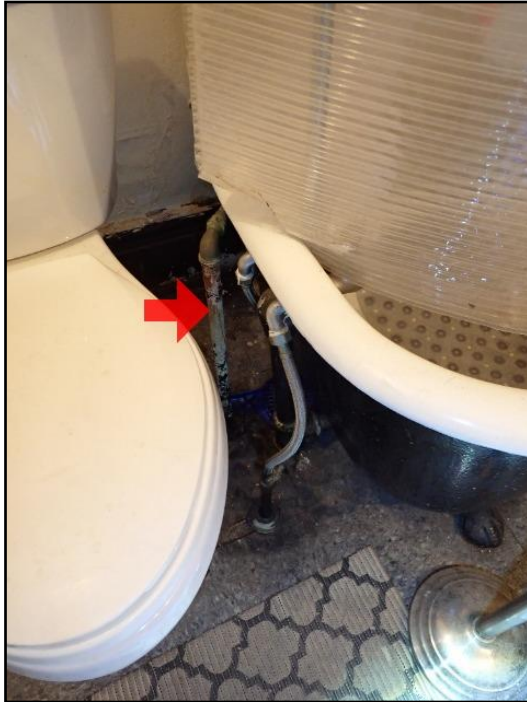
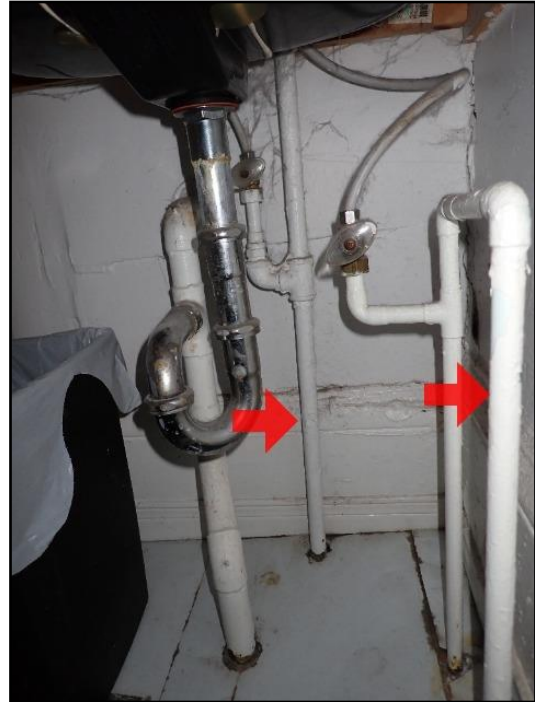
Condition: • Galvanized steel

This piping is beyond its normal service life. The interior is typically corroded reducing water pressure and volume. Eventually the pipe walls fail and leaking will occur.

Galvanized steel

Task: Replace

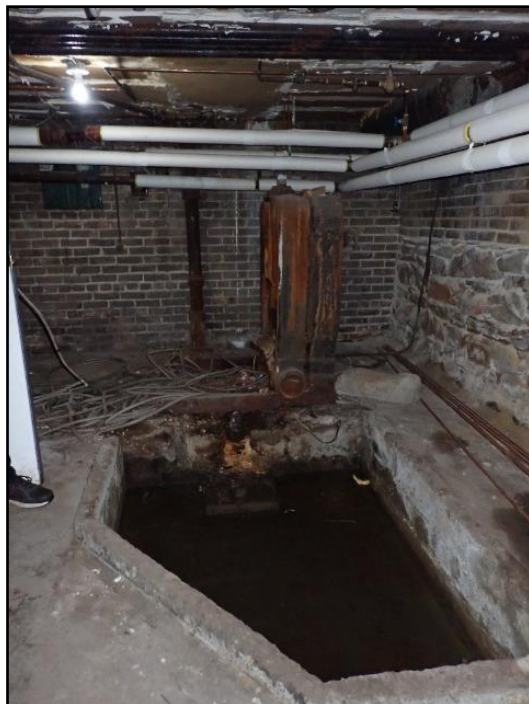
Condition: • There is a large cavity with water in it and an old rusted sump pump in the same vicinity.

It wasn't determined if this was in fact a sump pit or served some other purpose. The source of the water was not known (i.e. from downspouts, foundation drainage tile, groundwater, etc.).

Cavity on basement floor

Task: Further evaluation / Improve

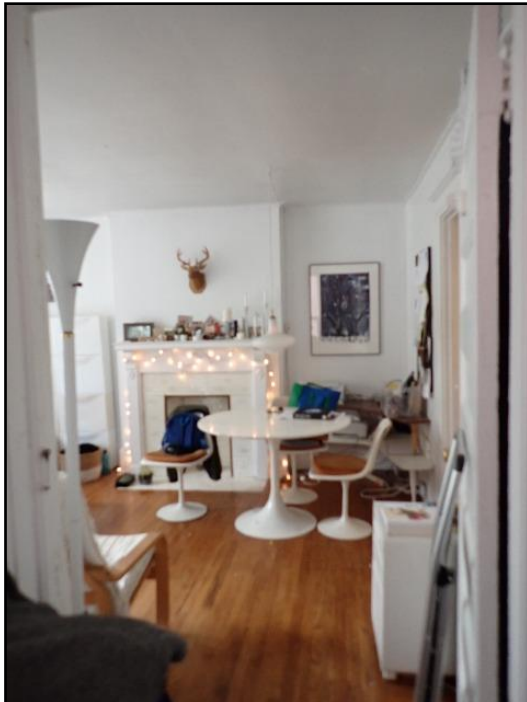
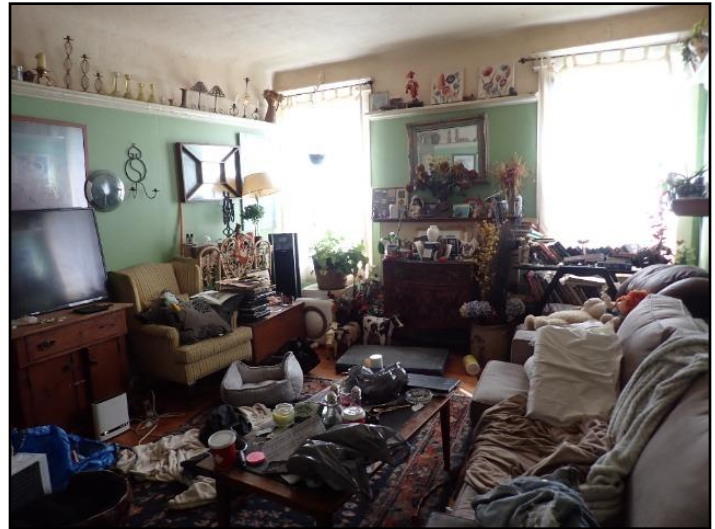
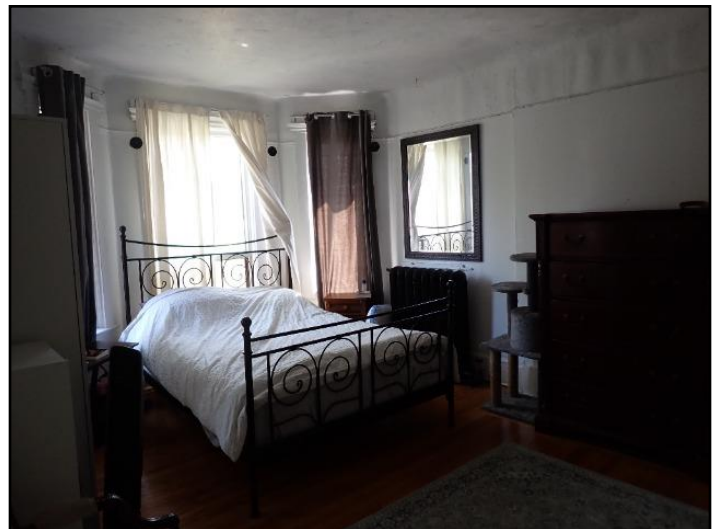
Condition: • The elements of the interior are in varying conditions, somewhat inconsistent and in many cases dated.

There are worn, damaged floors, older cabinets, older/some broken windows, poorly repaired ceilings/walls, trim details, etc.

Some units are neater/cleaner than others

A general contractor should be retained to give a more accurate assessment of costs.

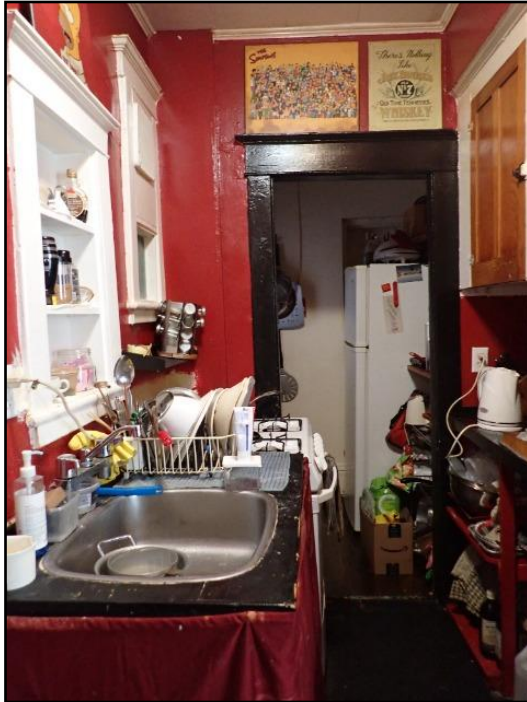
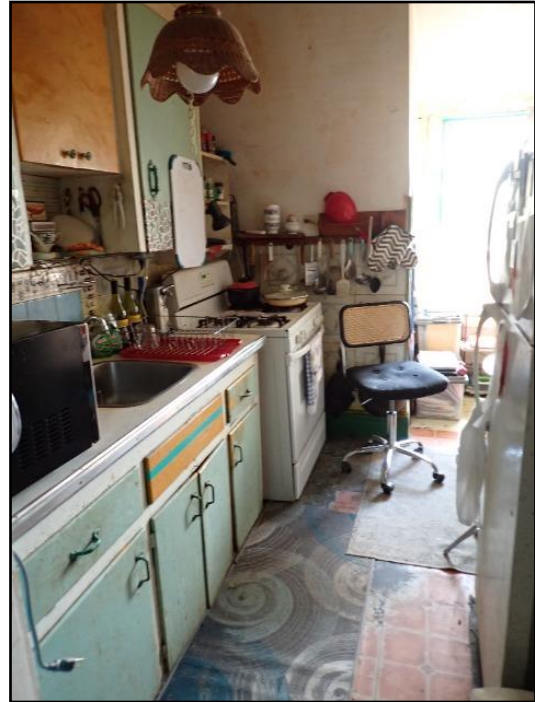
Kitchens are in varying condition

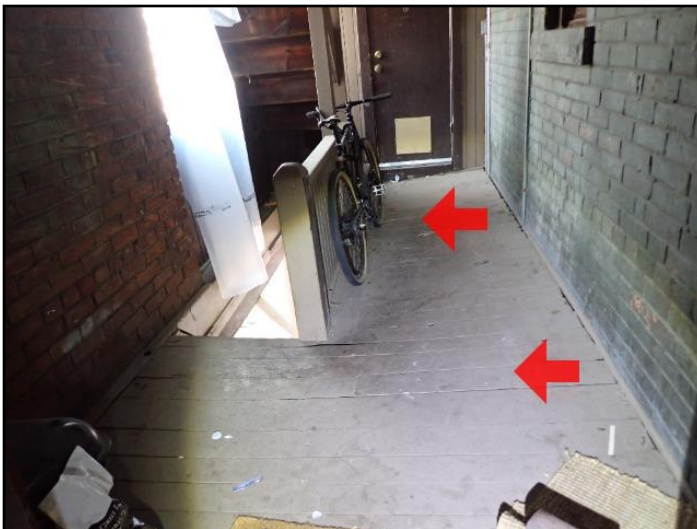
Condition: • Sloped flooring

The causes can be numerous and there is often more than one contributing factor.

Often it can be attributed to age (gravity/sagging). Other times it can be structure that is offset, undersized or has been altered or damaged over the years (e.g. notched floor joists, excessive spans, rearranged/removed walls, insect damage, etc.). Sometimes poor workmanship can also be a contributor.

Sloped flooring

The most common time to address them is when renovating or replacing the flooring.
